REPAIRS TO CONCRETE
PORT AND HARBOR STRUCTURES

MAX D. RODGERS
and/
JAMES M. SCHOFIELD

18 NOVEMBER 1991

Hydraulic and Coastal Engineering
Department of Civil Engineering
University of California
Berkeley, California

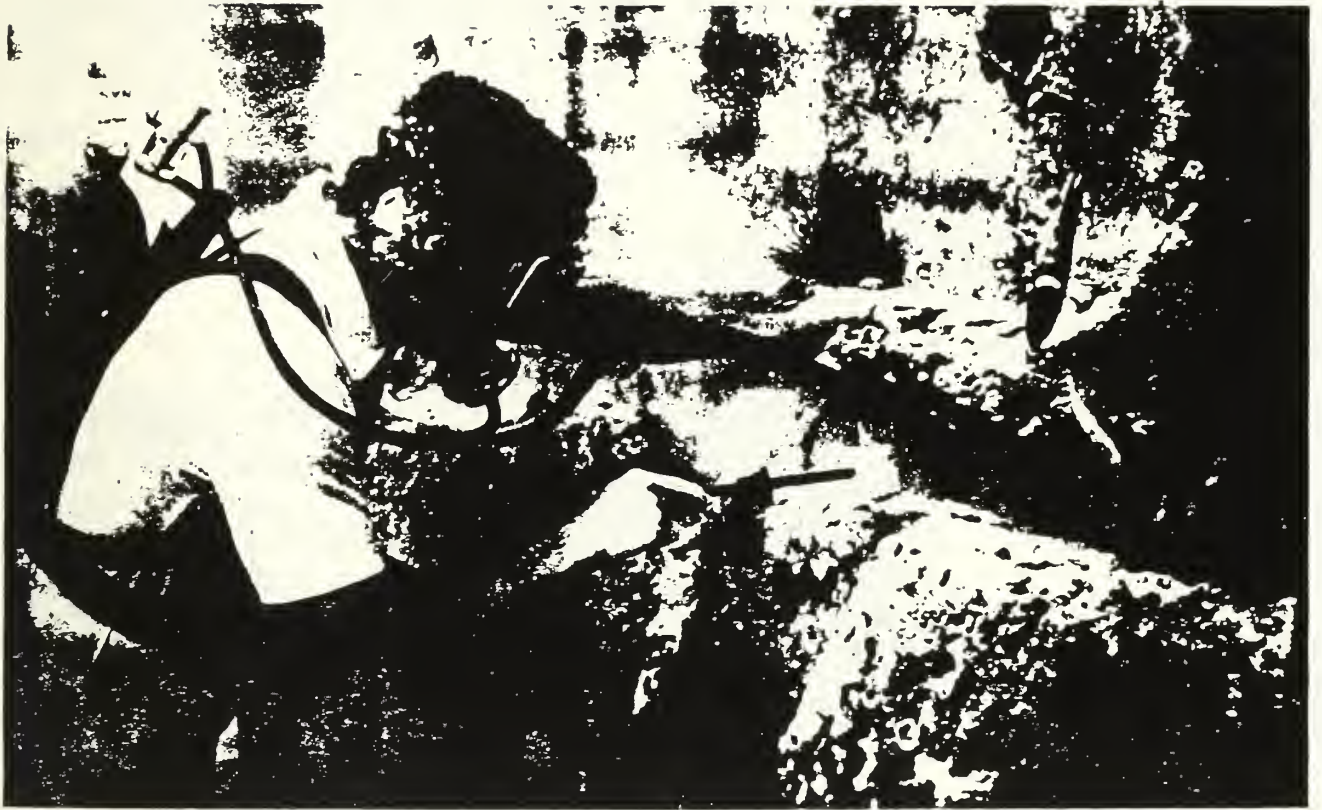
Figure III.2 Diver Engaged in Underwater Visual Inspection [47]

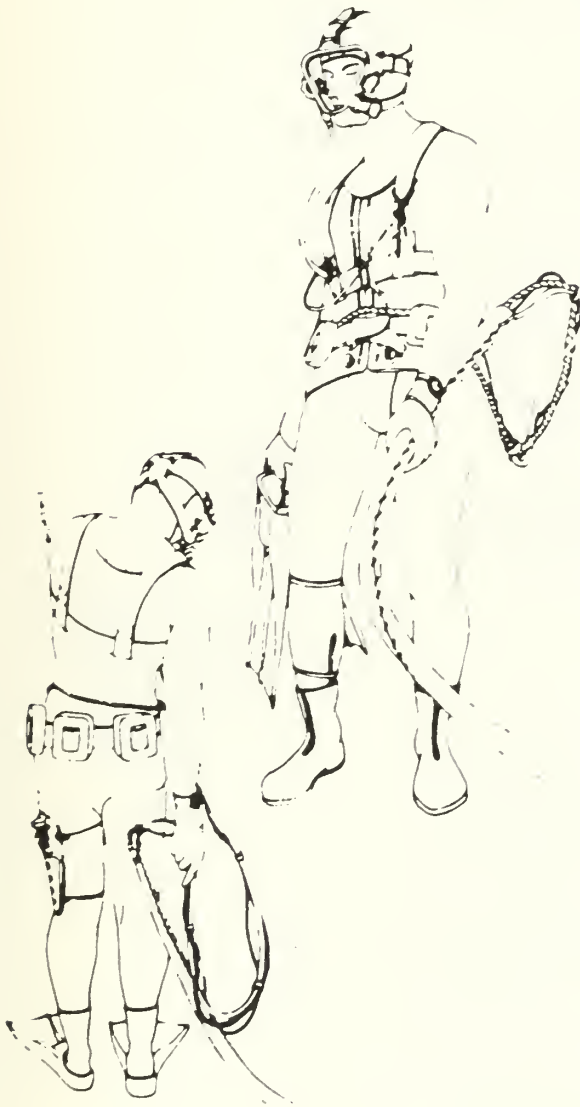
Minimum Equipment –	Diver's Mask USN MK 1 or Jack Browne mask Wet suit Weight belt Knife Swimfins or shoes Surface umbilical
Principle Applications –	Shallow water search Inspection and major ship repair Light salvage
Advantages –	Unlimited by air supply Good horizontal mobility Voice and/or line pull communications Fast deployment
Disadvantages –	Limited physical protection Limited vertical mobility Large support craft required
Restrictions –	Work limits – Jack Browne – Normal 60 feet/60 minutes Maximum 90 feet/30 minutes Work limit – MK 1 without come home bottle Maximum 60 feet Work limit – MK 1 without open bell Maximum 130 feet/10 minutes Work limit – MK 1 with open bell Maximum 190 feet/60 minutes Current – 2.5 knots max
Operational Considerations –	Ability to free ascend to surface required, with exception noted in Para 6 8 7 2 Adequate air supply system Standby diver required

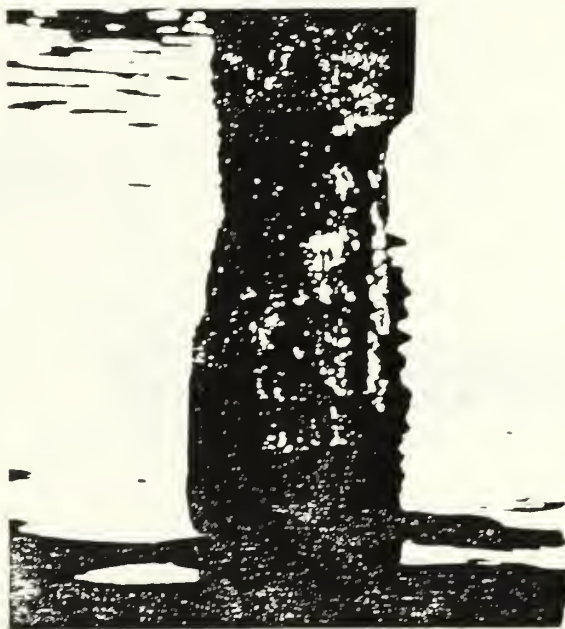
FIGURE IV.12

Type I, III and V are used when deterioration terminates at the water line or no more than one or two feet below.

Type II, IV and VI are used when deterioration runs the full length of the pile.

Typical condition where Types II and IV jacket should be used.

Typical condition where Types V or VI jacket should be used.

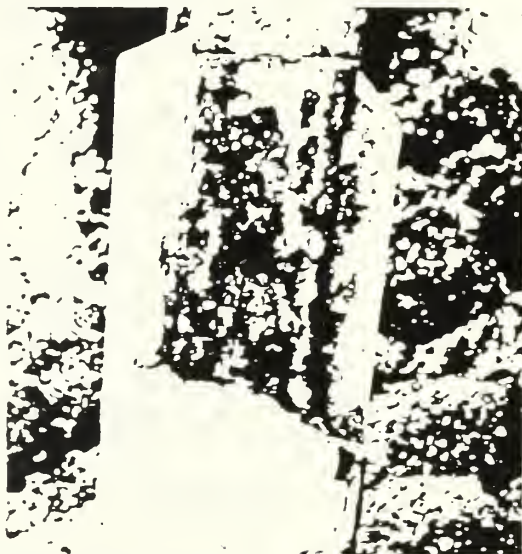
1. Clean pile surfaces of oil, grease, dirt and corrosion by sandblasting to "near white metal".
2. Place pile jacket form around pile. Standoffs of form material should be permanently attached to form or pile.
3. Seal interlocking joint with epoxy bonding compound and seal bottom of form against pile surfaces.
4. Place external bracing and banding materials.
5. Dewater form.
6. Fill bottom six inches of form with epoxy grout filler.
7. Fill form to top 6" with Portland cement grout filler.
8. Fill to 6" with epoxy grout filler. Form fillet and slope grout to web of pile.
9. Remove external bracing and banding, and clean any filler material deposited on form.

Typical condition where this repair method should be used.

FIGURE IV.13 Encasement of Steel Piles With Underwater Concrete

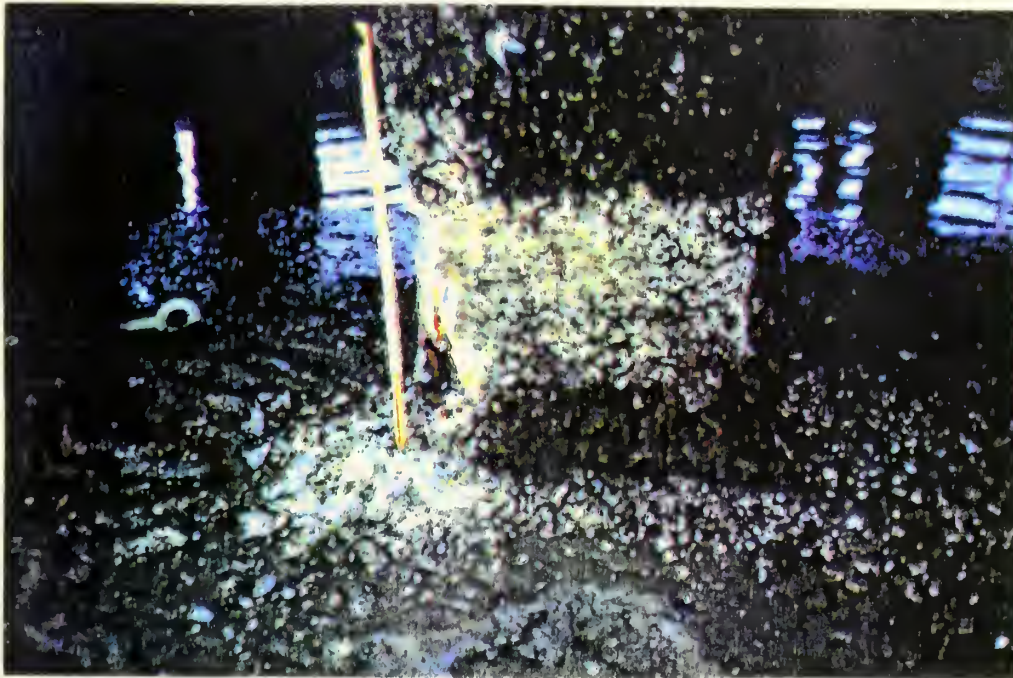
Photo V.3 Pile C2 (inboard)

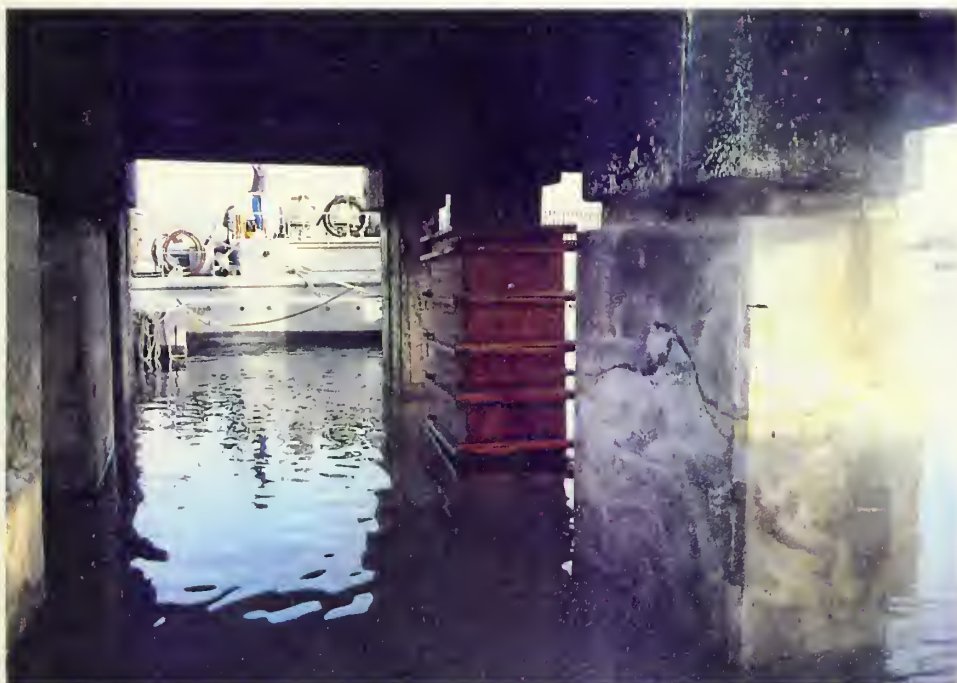
Photo V.10 WWF installed on piles A3, form installed on Piles B3
and completed repair on piles C3

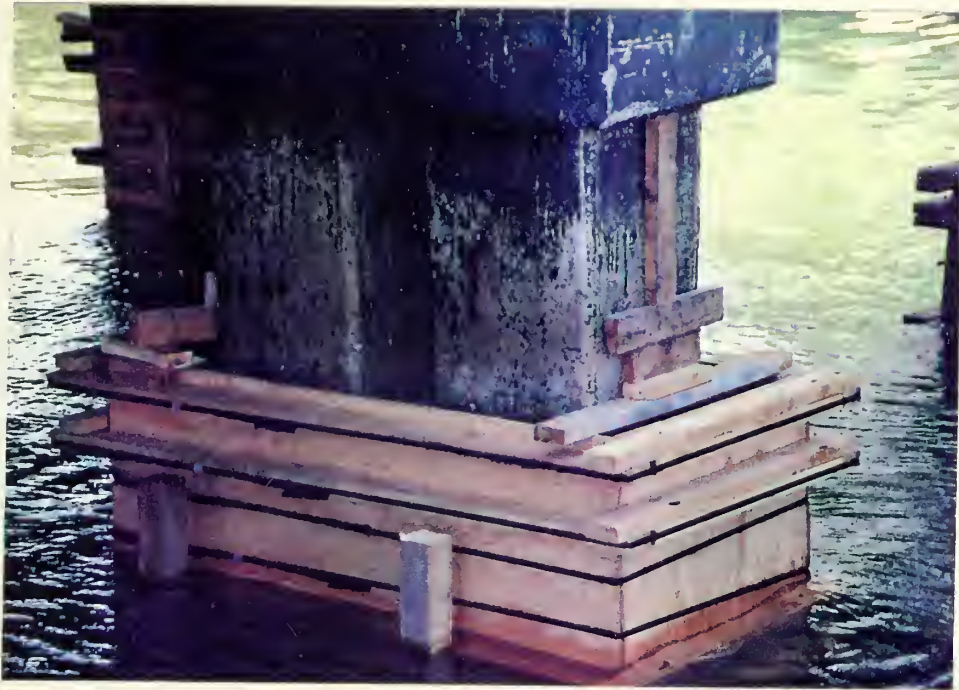
Photo V.11 Form inplace and braced on piles A2

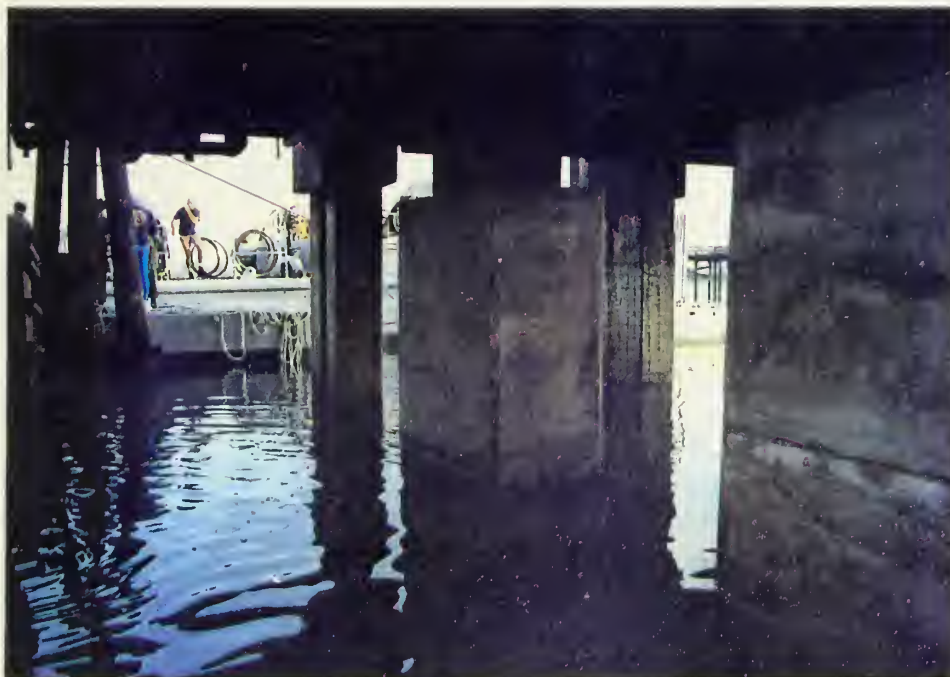
Photo V.16 Completed repairs on piles B2 and C2, WWF installed on
piles A3

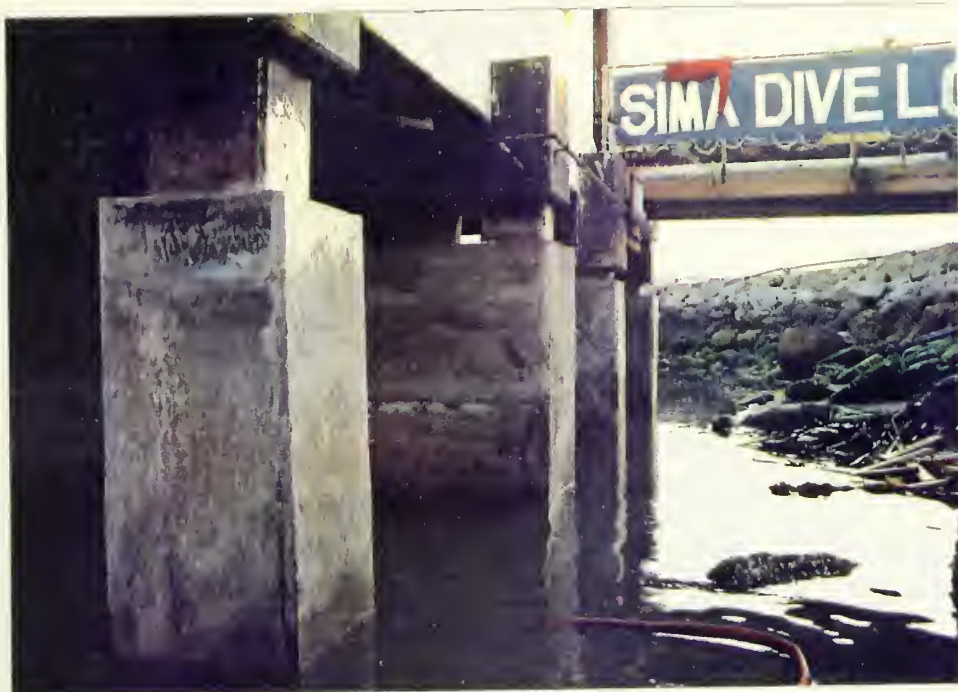
Photo V.17 Completed repairs to piles C1-C4

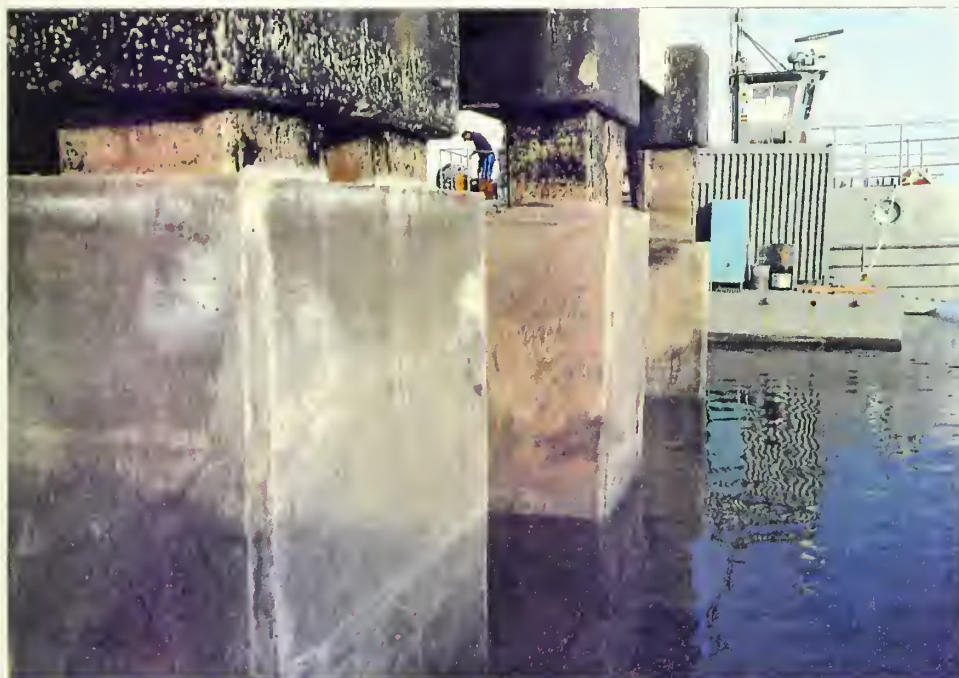
Photo V.18 Completed repairs to piles A4, B4 and C4

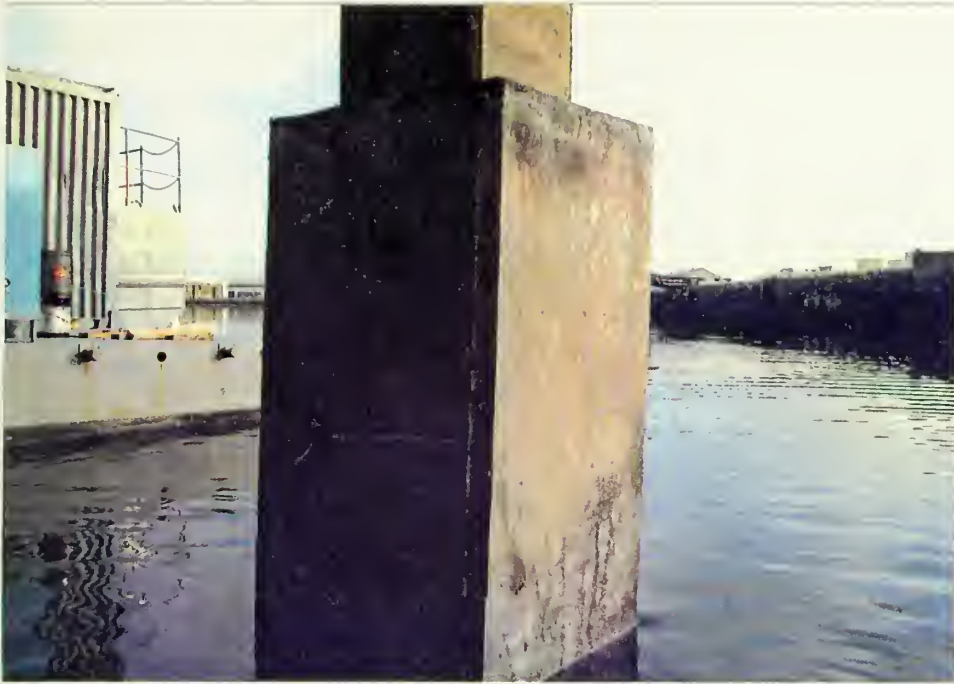
Photo V.19 Completed repair to Pile A4
